**REPORT OF INVESTIGATION  
INTO FATAL INCIDENT ON THE  
CLODAGH RIVER,  
CO. WATERFORD  
ON  
7th APRIL 2010**

**REPORT No. MCIB/180  
(No. 4 of 2011)**

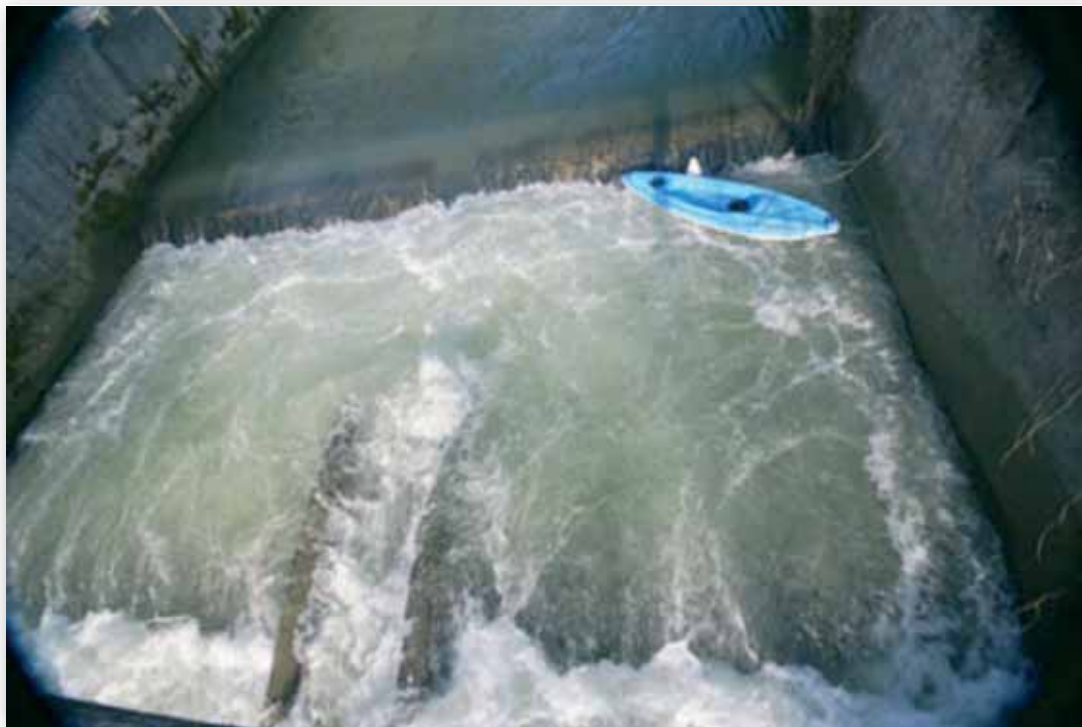
- 6.2 The back flow at Portlaw Weir was longer than half a kayak length. As a general rule a kayaker can only pass obstacles that cause water back flow of less than half of their kayak length. Back flow is shown in a diagram in Appendix 8.3 as is the general flow of water through the weir. The design of this weir made it impassable regardless of the water flow over it.

Note that the Bic Sports Kayak sit-on type Kayak is lodged firmly in the weir back flow after twelve hours.

- 7.4 The Local Authority should supply and install appropriate lifesaving equipment, including permanent exit ladders from the weir.
- 7.5 The Local Authority should prevent the use of the weir in its current design form.

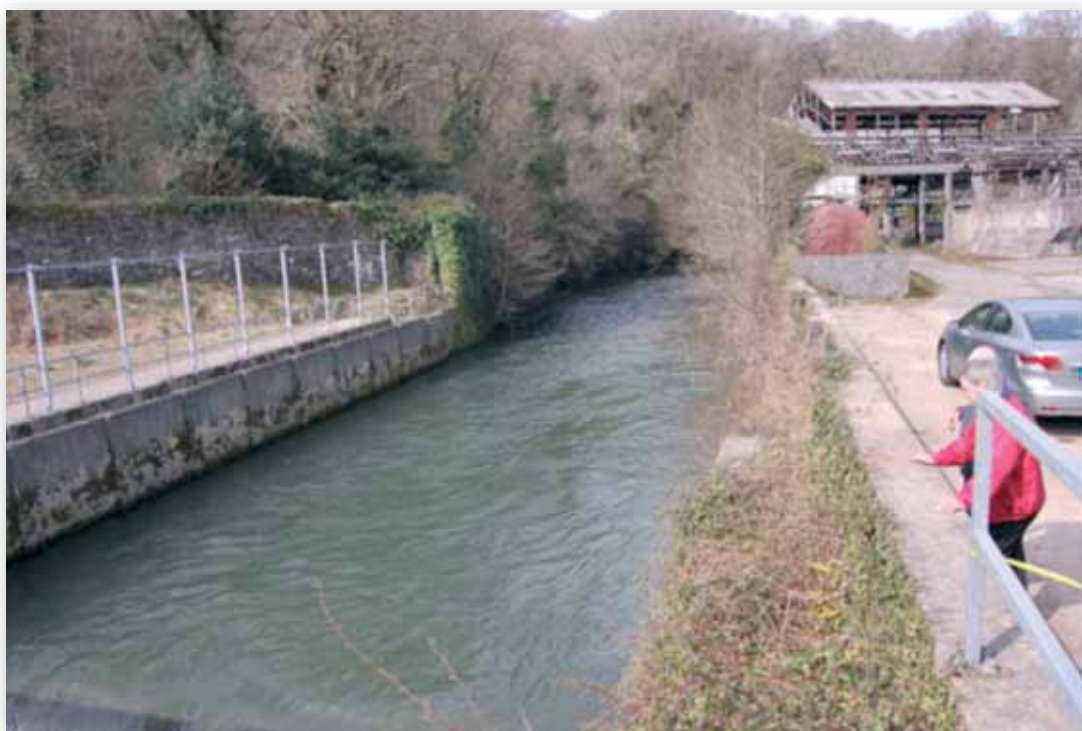
- 6.7 There was no safety equipment/life saving appliances available at the weir.
- 6.8 The weir at Portlaw is, by design, next to impossible to escape from without the use of lifebuoys and or an access ladder.

Above is the entrance to the weir. After the two men re-entered the water there was no easy way back.

- 7.3 The Local Authority should provide adequate and visible signage to warn users that the weir is dangerous and un-navigable. This signage should extend beyond any landing or launching location so that the danger to users entering the approach to the weir are warned in sufficient time.

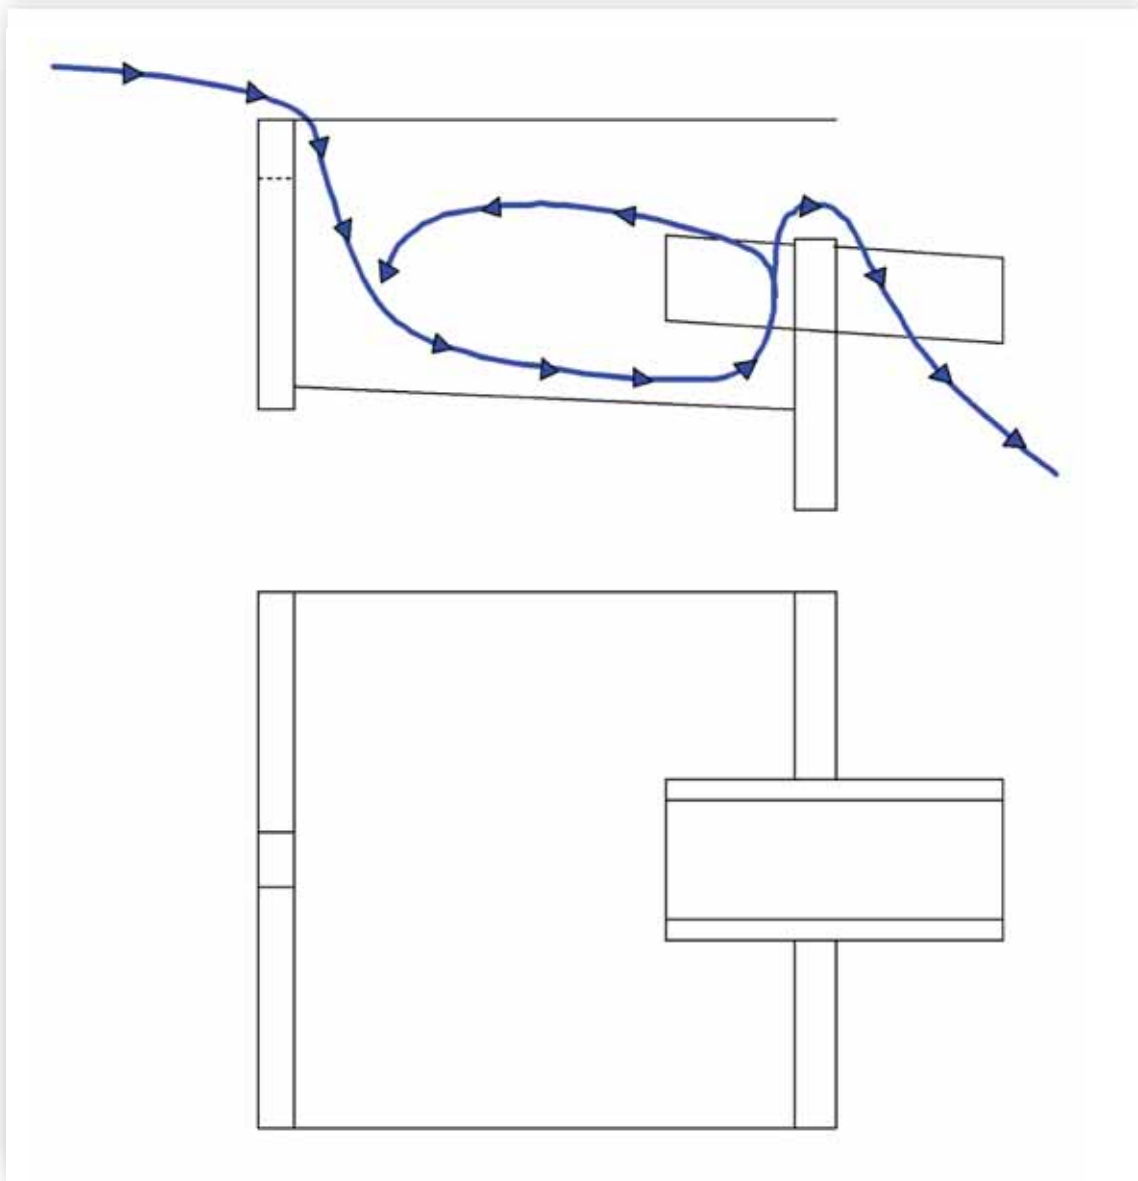
### Appendix 8.3 Diagram of Weir.

The top part of this diagram shows the flow of water through the weir. Note that the flow splits in two at the top of the lower weir wall on the right side on the diagram. The flow that runs from right to left is the back flow. From the top photograph in 8.2 one gets some idea of the scale of the weir and the length of the back flow. This weir cannot be run.

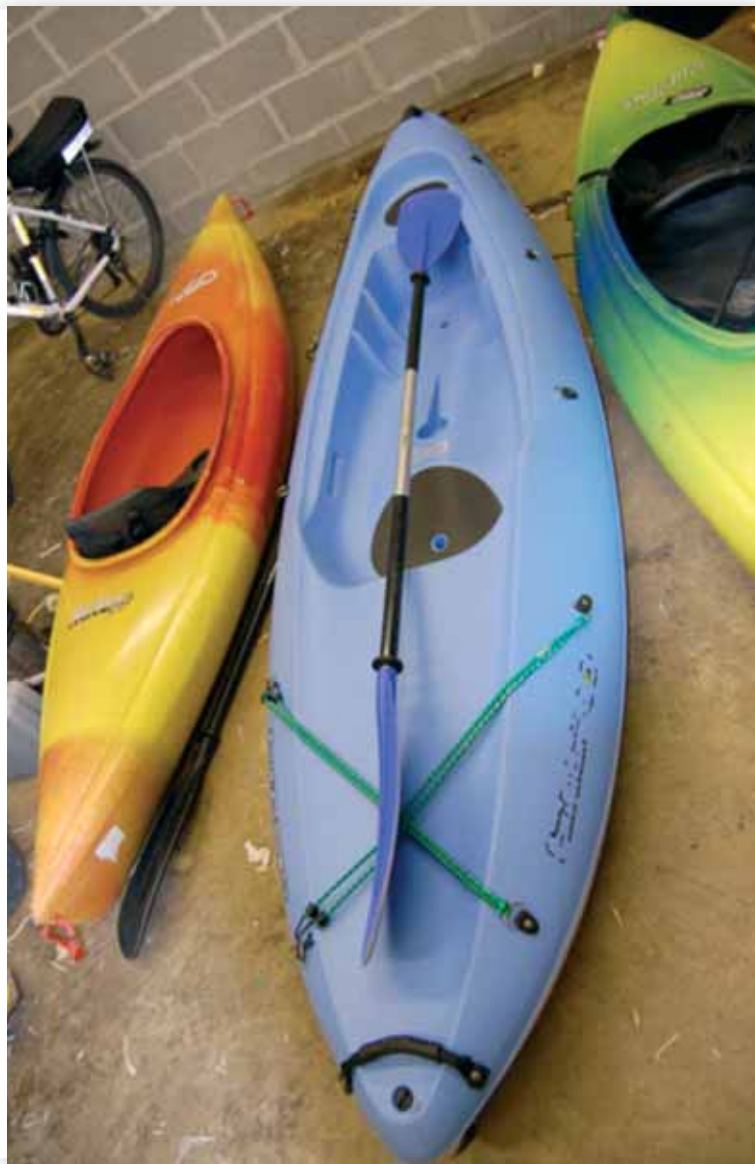
### Appendix 8.4 Kayaks at time of inspection in Tramore Garda station.

- 6.4 No risk assessment of the proposed route had been undertaken.
- 6.5 None of the men had Swift Water Rescue Training.
- 6.6 The equipment that could be examined was found to be in good condition. However, it was not best suited for swift water/white water kayaking.

2 x Plastic Old town XT on left and right.  
Bic Sports Kayak blue in the centre.  
All are in near perfect condition.
