**REPORT OF THE
INVESTIGATION INTO
THE INCHAVORE RIVER
KAYAKING INCIDENT
CO. WICKLOW
ON
13th NOVEMBER 2014**

**REPORT NO. MCIB/241
(No.9 OF 2015)**

Report MCIB/241 published by The Marine Casualty Investigation Board.
Printed 28th August 2015.

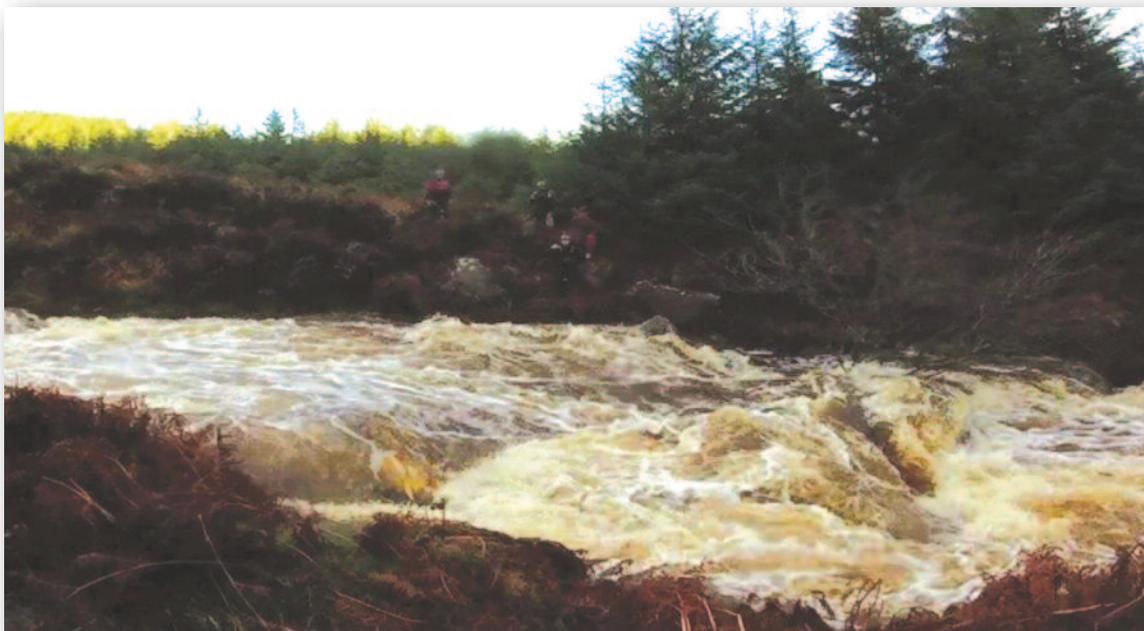
Photograph No.1 - River on the day of the incident

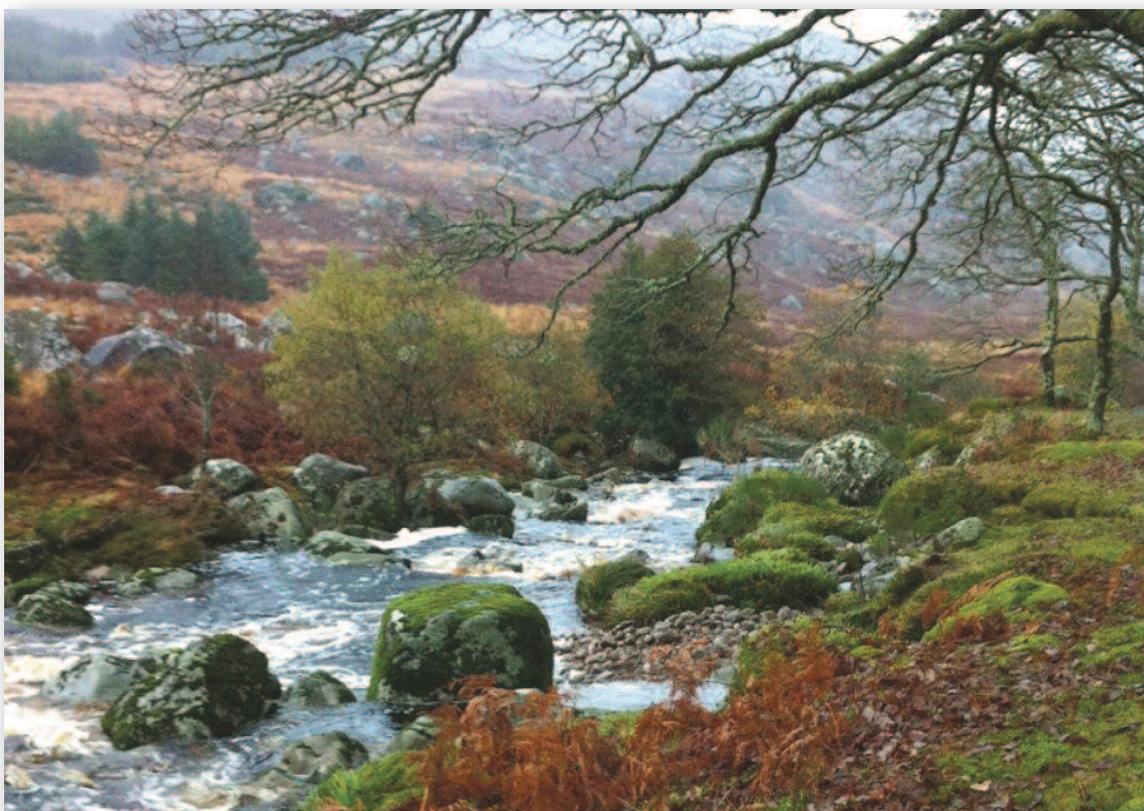
- 4.1 On Tuesday the 18th November 2014 the river and riverbank were surveyed. The river level had dropped, exposing rocks and various other obstacles. During the survey of the bank, several large trees and branches were noted as well as several areas where the flora was disturbed as a result of the search. The land on either side of the bank was not easy terrain to negotiate and no mobile phone signal was available (See Appendix 7.3 - Photographs).

Photograph No.2 - River on the day of survey

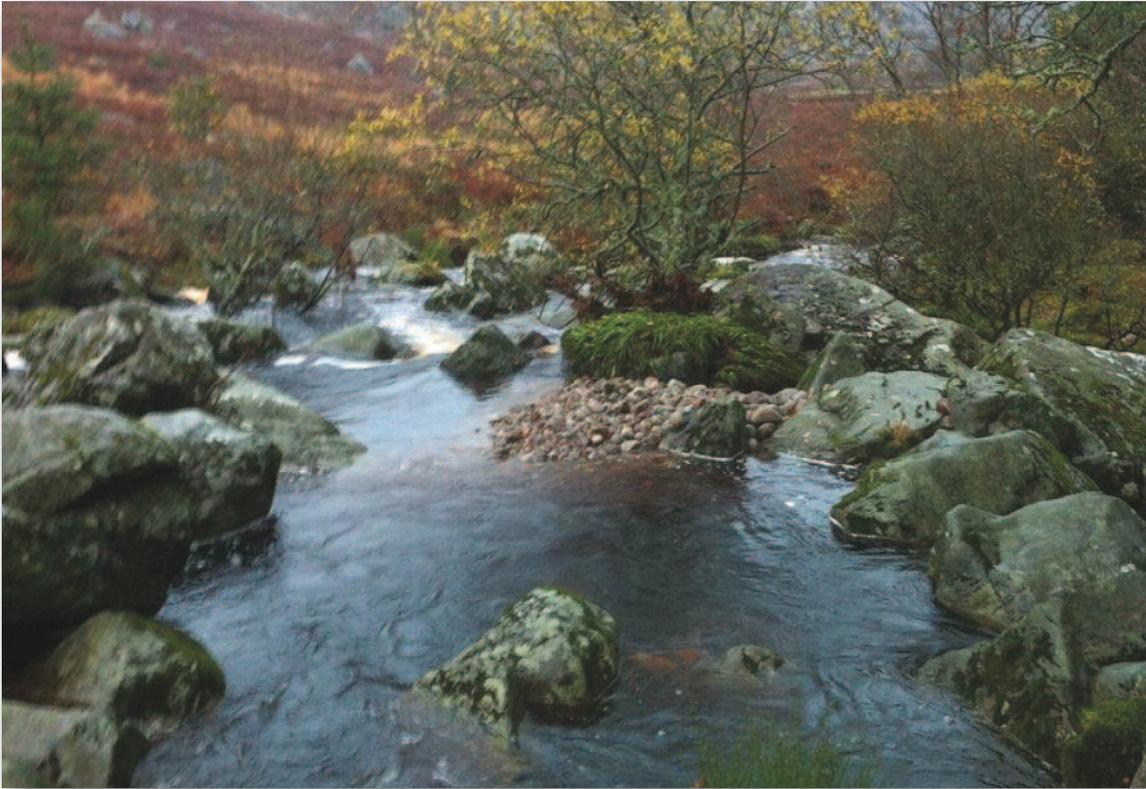
Photograph No.3 - Showing exposed rock when the river is at a low level

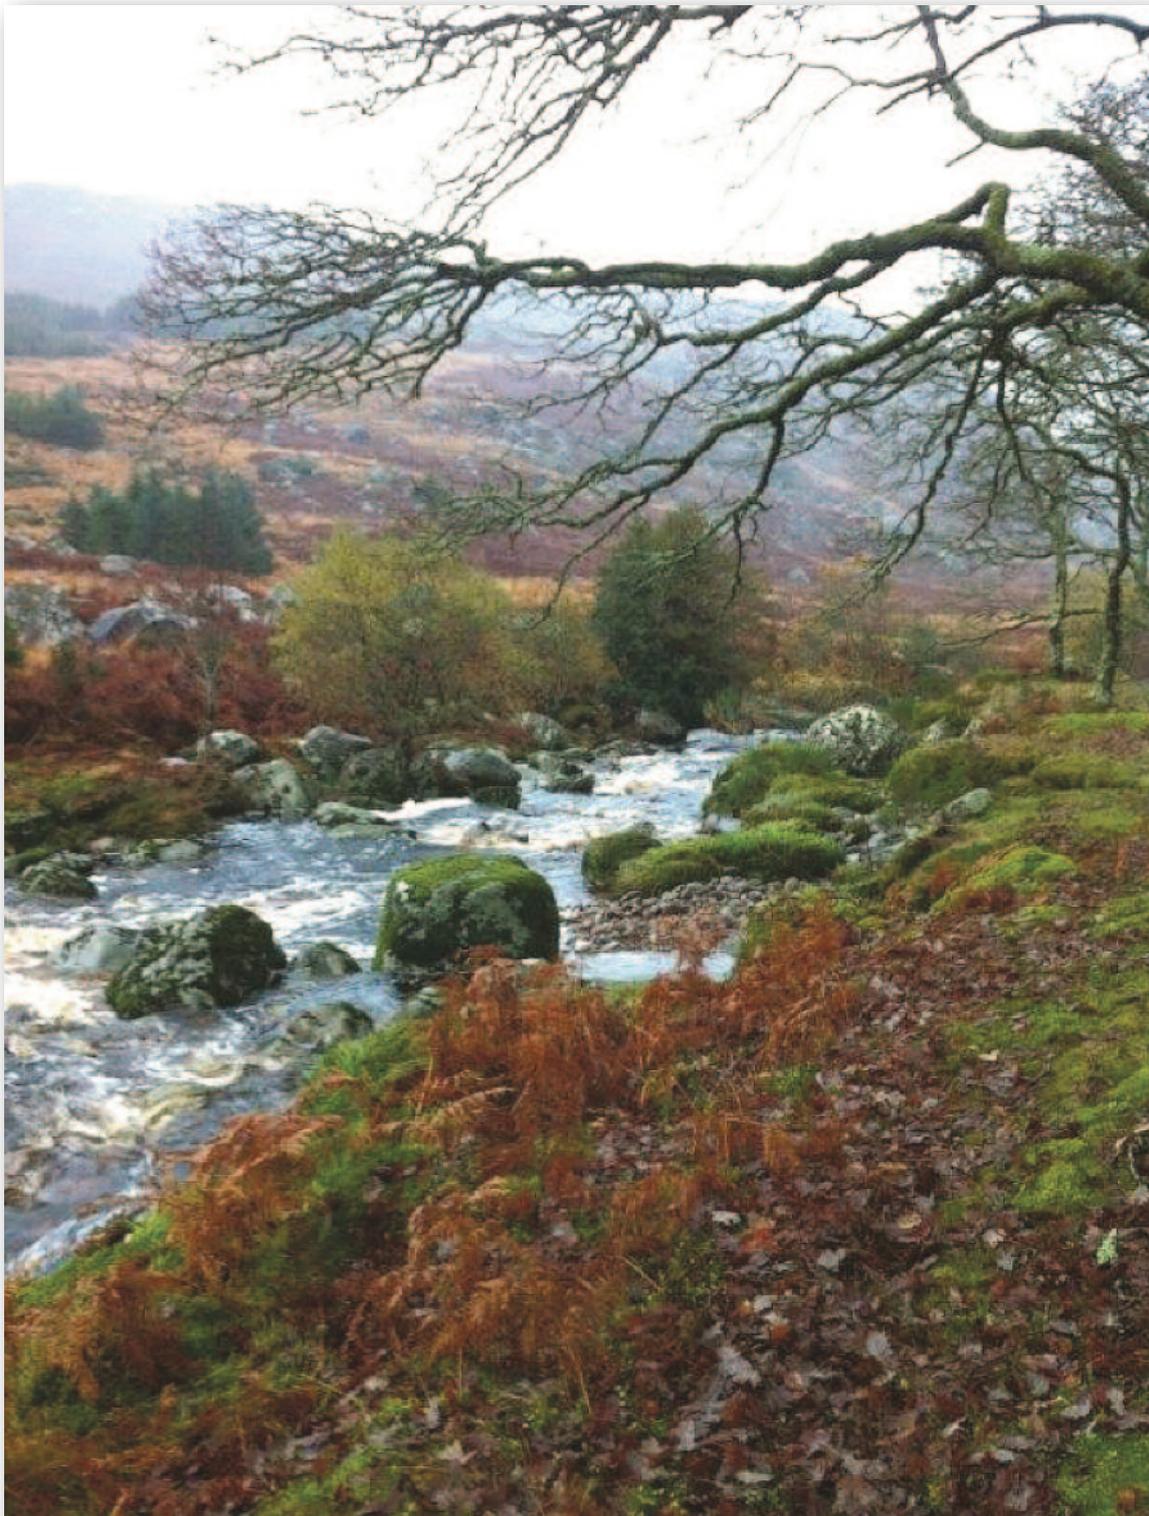
Photograph No.4 - Showing over hanging branches

13. Page 18 Photograph 4 – Although this photograph shows overhanging branches, these particular branches would be of little concern to paddlers as they are so high above water level. The branches in the river in photograph 1 and those on the island and banks in photograph 3 would be the types of overhanging branches that could be hazardous to canoeists.

MCIB RESPONSE:
Point 13. This photograph was taken at the same time as photograph no. 2 but from a slightly different angle.

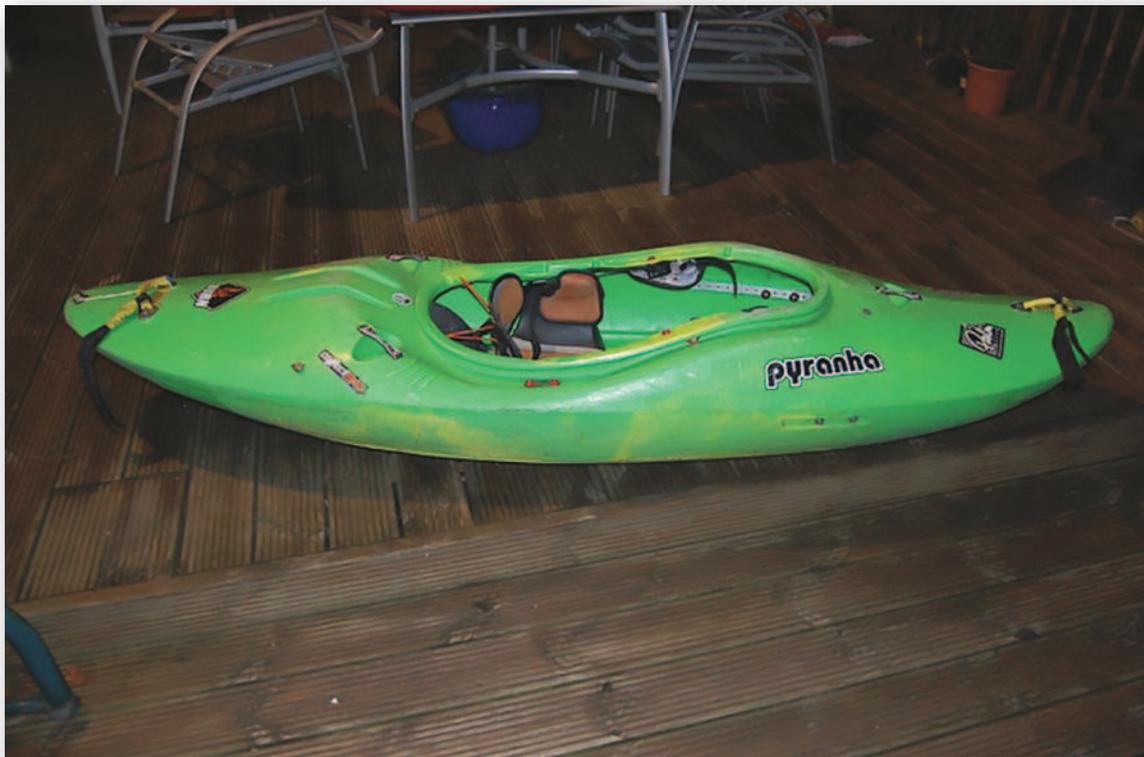
- 4.3 The casualty's kayak was surveyed after the incident. The hull had scuffs and marks, consistent with normal use and there was a small repair in the hull bottom under the seat. The kayak was in good repair and fit for purpose (See Appendix 7.3 Photograph No.5).

Photograph No.5 - Picture showing the casualty's kayak on day of survey
